TECHNICAL UPDATE

5

Number June '82

Distributed as a free service to all Lazair owners

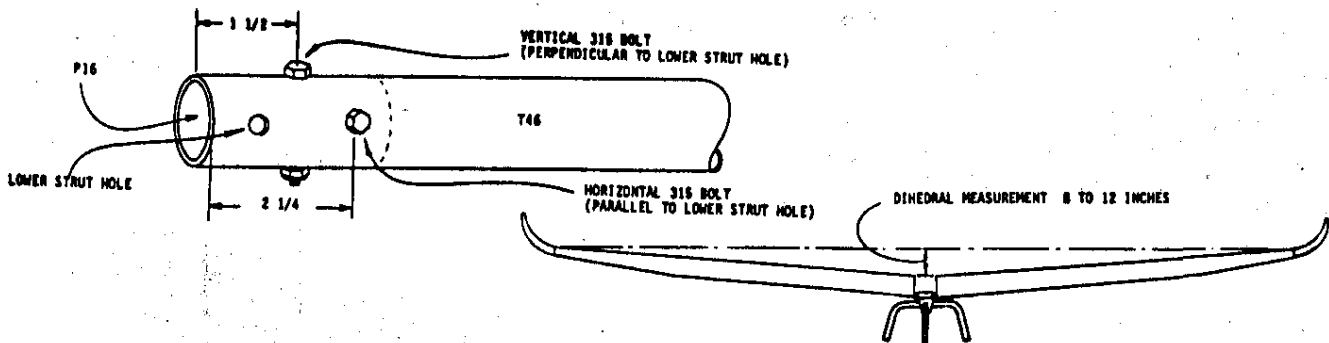
5.1 LOWER STRUT PLUG INSTALLATION

Early Lazairs (the ones with the spoked wheels) were designed so that the P16 strut plug extended beyond the end of the T27 strut tube. Later models (with the "Tundra Tires") have a larger diameter axle (which increases the spacing between the F6 gussets to 1 1/4 inches) and therefore the P16 must be installed so that it is flush with the end of the T46 strut tube. If you have one of the first few kits shipped after the changeover, your assembly instructions regarding the position of the P16 may have been somewhat ambiguous. Please check to make sure that your P16's are installed as shown below, and there are two 315 bolts in each strut plug (P17's as well as P16's). As a secondary check, you can measure the Dihedral by stretching a string between the top of the D-cells at the tips. The distance from the string to the top of the D-cell at the root should be between 8 and 12 inches.

If it is necessary to reposition your P16 plugs, it should be possible to do so without having to scrap either the strut or the plug. Wherever possible, use existing holes in the strut. Rotate the P16 and drill new holes in it as necessary. Make sure the center of the lower strut hole is at least 1/2 inch from the end of the strut.

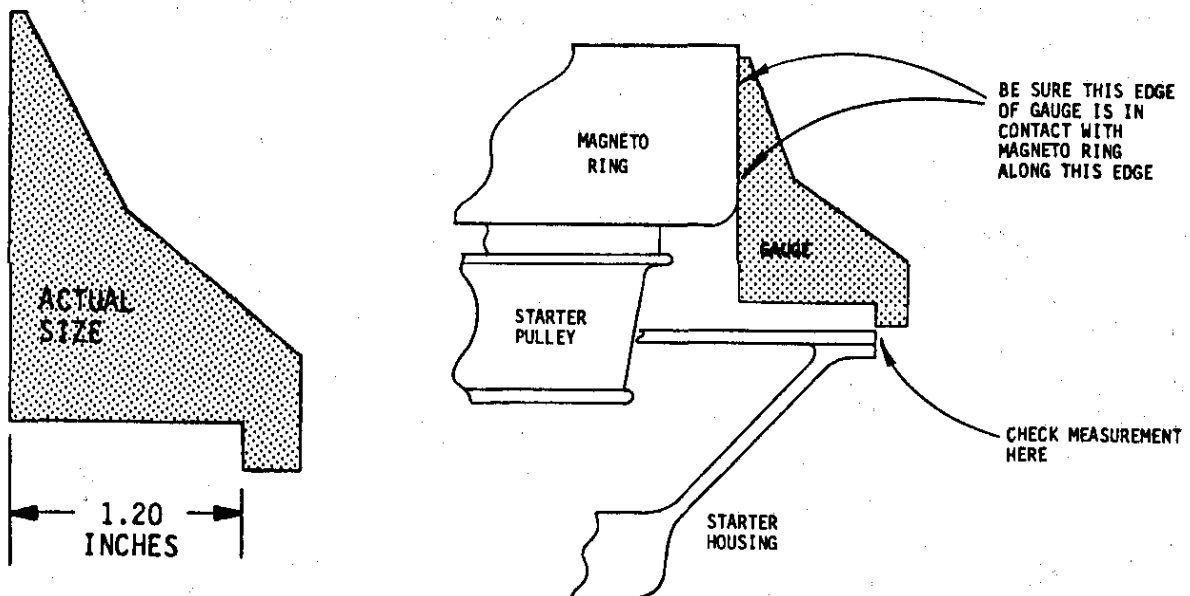
5.3 CENTERING OF STARTER ASSEMBLY

To prevent possible damage to the starter pulley on the rotax engine, it is essential that the starter pawl assembly be centered properly. If you remove the starter assembly from the engine or if the engine is removed from the engine mounting assembly, the starter assembly position should be checked after re-assembly as follows:

First, make a measuring gauge from thin sheet metal as shown. Use this gauge to check the radial spacing between the starter housing and the magneto ring. Check the spacing at four places (approximately equally spaced) around the circumference and make sure it does not vary more than plus or minus 1/32 of an inch. If necessary, loosen the 5/16 inch mounting bolts and re-position the engine on the mounts.

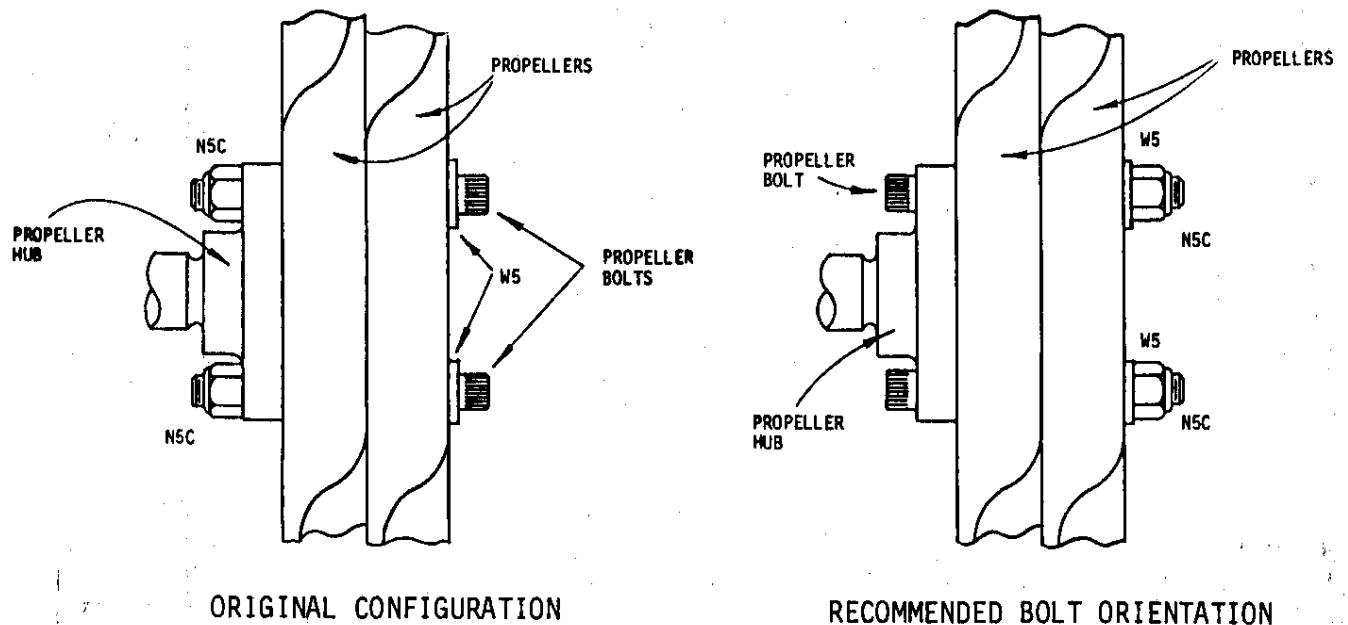
5.4 PROPELLER BOLTS

Since the introduction of the rotax engine in November '81 we have had three reports of broken propeller bolts. After examination, it was determined that one of these failures was a result of the engine being run for a considerable length of time with the propeller bolts loose. The other two resulted from the propeller bottoming on the crankshaft nut rather than seating properly on the hub. A special notice regarding this potential problem and a suggested method of checking the depth of the counterbore in the propeller was mailed to all owners of kits shipped prior to January '82 (those who we thought could have experienced this problem) but it appears that some of the notices either did not reach their destination or were ignored by their recipients.

The threads on the bolt not only reduce the cross sectional area of the bolt by approximately forty percent, but they also introduce a stress concentration, which, under fatigue loads, can be as high as 2.7 to 1. By reversing the bolts, the threaded part of the bolt is moved from the area of maximum stress to the area of minimum stress.

To reduce the possibility of a bolt failure (even if a propeller is improperly installed) all kits shipped after May 17, 1982 have the bolts inserted through the hub in the opposite direction to that in the original configuration. To increase the margin of safety, it is recommended that owners of Lazairs shipped prior to May 17, 1982 reverse their propeller bolts as shown below.

This requires drilling out the holes in the propeller hub to 5/16 inches diameter, and allows the part of the bolt which goes through the hub (where the stress is highest) to be the full diameter. As originally configured, the bolts were threaded into the propeller hub.
