## TECHNICAL UPDATE

# 6

Number September '82

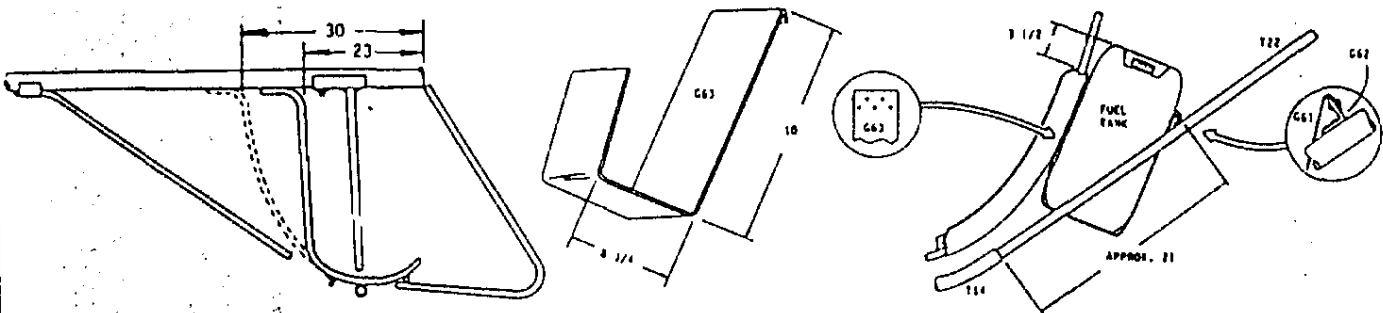
Although as stated earlier, we do not supply a conversion kit for the new 20 Litre (5 U.S. Gal.) fuel tank, many owners have installed the larger tank and now that the new FAA rule specifically allows a 5 gallon tank, many more owners may wish to make the conversion. As stated previously, these changes are not recommended unless you have had experience and have access to the equipment required for bending thin wall aluminum alloy tubing. However, for anyone who is qualified to do the job, the following guidelines are provided:

1. To achieve the proper centre-of-gravity, it is necessary to move both the fuel tank and the pilot forward. This involves rebending and repositioning the seat tube (T44) as shown (or replacing the T44 with the new T60 seat tube).
2. Make a saddle for the new tank so that the weight is carried by the T22's at the rear and by the seat tube at the front. Do not attempt to support the weight of 5 gallons of gasoline (about 140 pounds at 4 g's) entirely by the T22's.

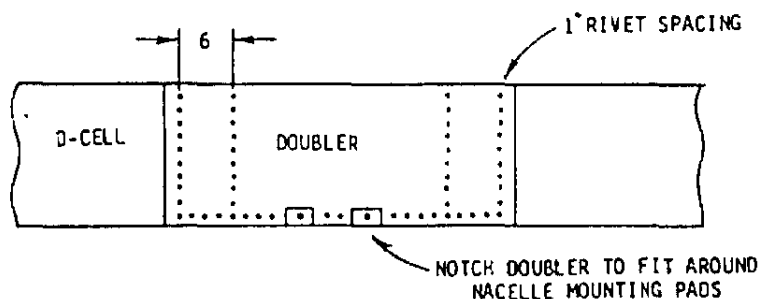
In Update 5, item 5.7 we stated that the use of Rotax engines on Lazair's with .016 inch leading edge skins was not recommended. This statement was not based on any particular experience, but rather on a lack of experience. At that time, we had one demonstrator flying with this combination, but we did not have sufficient time on it to evaluate the results. Since then, our demonstrator has continued to perform well, however, one dealer who installed Rotax engines on .016 inch D-Cells reported that one of his D-Cells acquired a slight buckle just inboard of the Nacelle when he shut down the engines and one of them backfired. Based on this, we are obviously not recommending the installation of the larger engines on the lighter D-Cells.

However, for those who have already made the conversion and those who probably will (in spite of our recommendations), we suggest that, as a minimum, you rivet on a two foot wide doubler of .020 2024-T3 aluminum alloy over the leading edge of the D-Cells under the Nacelles.

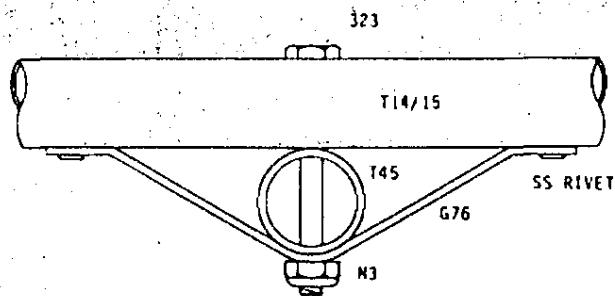
In the assembly manual for the rudder pedal kit, there is a reminder that when one rudder pedal is pushed down, the other one must come up, and therefore you should not attempt to push on both pedals simultaneously. However, for whatever reason, people do occasionally push down on both pedals. While reasonable pedal pressure does not cause a problem, excessive force will bend the two 323 bolts which hold the nosewheel axle to the side tubes. To alleviate this problem, we are now including with the rudder pedal kits two small gussets (G76) to help support the axle. If you have an earlier rudder pedal kit and wish to add these gussets, you can make them yourself from two strips of aluminum alloy .040 to .080 inches thick, 1/2 inch wide and 6 inches long. Bend and install the gussets as shown.

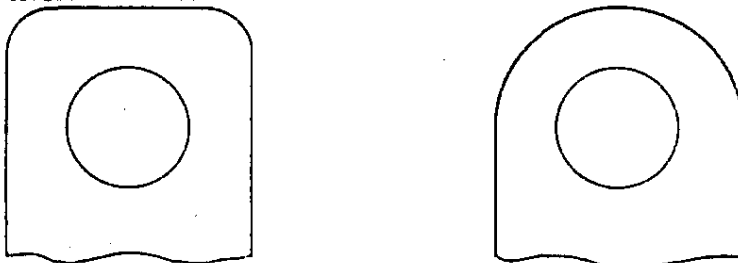
A few kits were shipped recently with front fittings shaped as shown at left below. If you assemble the control system with the fitting as shown, you will probably find that it interferes with the pushrod when you move the control stick to deflect the ailerons.

To work properly the fitting should be cut, filed or sanded as shown at right above.

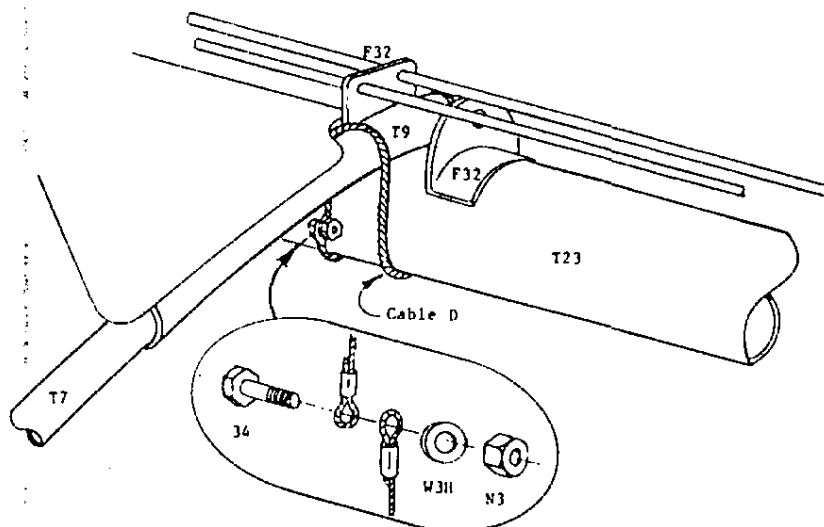
Approximately a year ago we investigated a potential problem of broken F32 pushrod guides causing the leading edge of the stabilizer to become detached from the boom. At that time, it was determined that it would be necessary to break two F32 fittings to cause a problem, and even if this did happen, the stabilizer would be held in position by the 126 pushrods to permit a safe emergency landing. This conclusion was substantiated by structural testing on the ground, flight testing, and field reports.

However, we have since received one report of F32 breakage, believed to be caused by severe lateral loading on the tail caused by side-slipping (this was not possible before the rudder pedals were incorporated). Fortunately, this did not cause a serious problem and the aircraft made a normal landing, but it does renew our concern. This situation is not relevant to the newer kits which incorporate the folding tail because the stabilizer is secured to the boom by the hinge brackets. However, if you have one of the earlier Lazair™s and you intend to execute some of the higher stress maneuvers possible with the rudder pedal conversion, we suggest the use of a small safety cable wrapped around the boom and T9 as an added precaution. If you cannot obtain the cable locally, we can supply one at a nominal cost of \$5.00 (including hardware). Please order "Cable D Kit".
